# ETIOLOGY OF GINGIVAL RECESSION WITH ROOT EXPOSURE

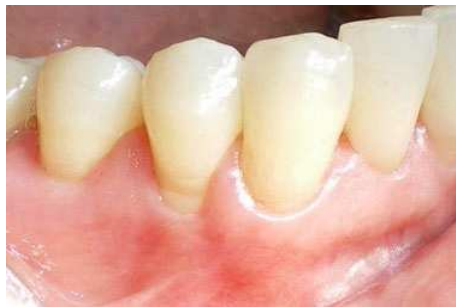
Figure 1

This patient is a 57-year-old Caucasian female who had orthodontic therapy as an adolescent. She presented complaining of tenderness around tooth #21. She had previously had bonding on the buccal of #21. The bonding had obviously not stopped the recession from progressing as is evidenced by recession apical to the bonding. (Figure 1)

Achieving complete root coverage is possible in Class I and Class II recession defects because the interdental soft tissue and bone are still intact. The patient is classified as a Miller Class II recession.

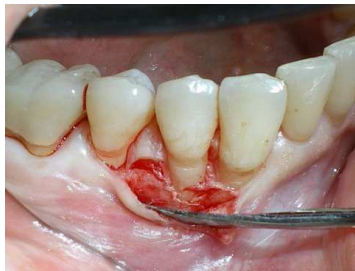
Figure 2

The proposed treatment was a connective tissue graft harvested from the palate under local anesthesia. The root surface shows a large amount of bone loss. The etiology of the recession was position of the tooth in the alveolar housing and toothbrush abrasion. The tooth is literally “out of bone”. (Figure 2) The patient admits to “hard brushing habits”. It is very common for patients to have several etiological factors causing the root exposure. Treatment consisted of: 1 - Removal of facial bonding material and 2 - mechanical and chemical treatment of the exposed root to remove palqued calculus and placement of a connective tissue graft. The connective tissue graft was secured by a Vicryl Rapide suture.

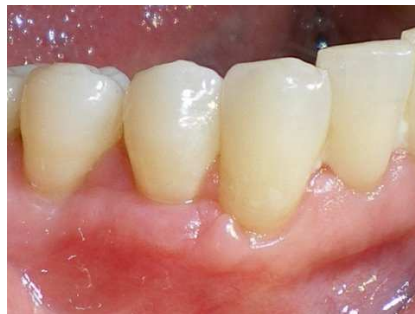
Figure 4 shows the final result 4 weeks after surgery. The postoperative result shows an increased amount of attached, keratinized tissue and 100% root coverage. The patient was thrilled with the excellent esthetics with root coverage.

The key to the success of this case was early intervention. Placing larger and layer bondings do not help the patient. My recommendation is to do a complete periodontal exam measuring pocket depth and recession at least once a year. Connective tissue grafts should be done when the recession reaches 3mm from the CEJ to the gingival margin. Placement of a composite restoration covering recession will not stabilize further loss of attached gingiva in the areas. This case really demonstrates the excellent postoperative color match with increased zone of keratinized tissue and complete root cover.
